6
National Dam Safety Program.
High Bridge Dam, Susquehanna River Basin,
Commonwealth of Pennsylvania,
Schuylkill County (NDS-PA-679).
Phase I Inspection Report.

HIGH BRIDGE DAM

PHASE I INSPECTION REPORT

11
SEPTEMBER 1978

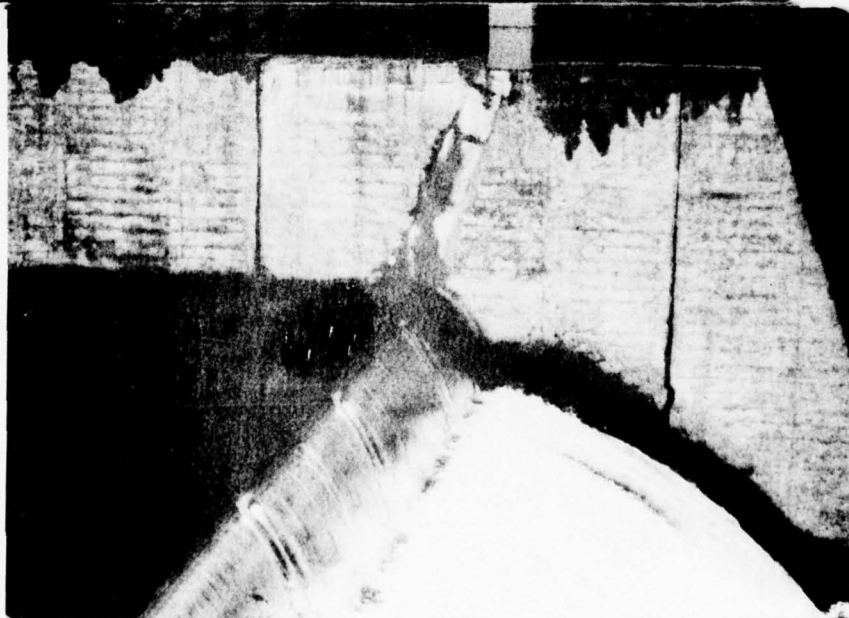
Left Section
Of Spillway
Wall

The spillway outlet chute is a concrete channel with vertical walls. Considerable cracking and deterioration of the walls was noted. The channel leads to the stilling basin downstream beyond which the discharge returns to the natural stream channel. Refer to Appendix D, Plate VII.

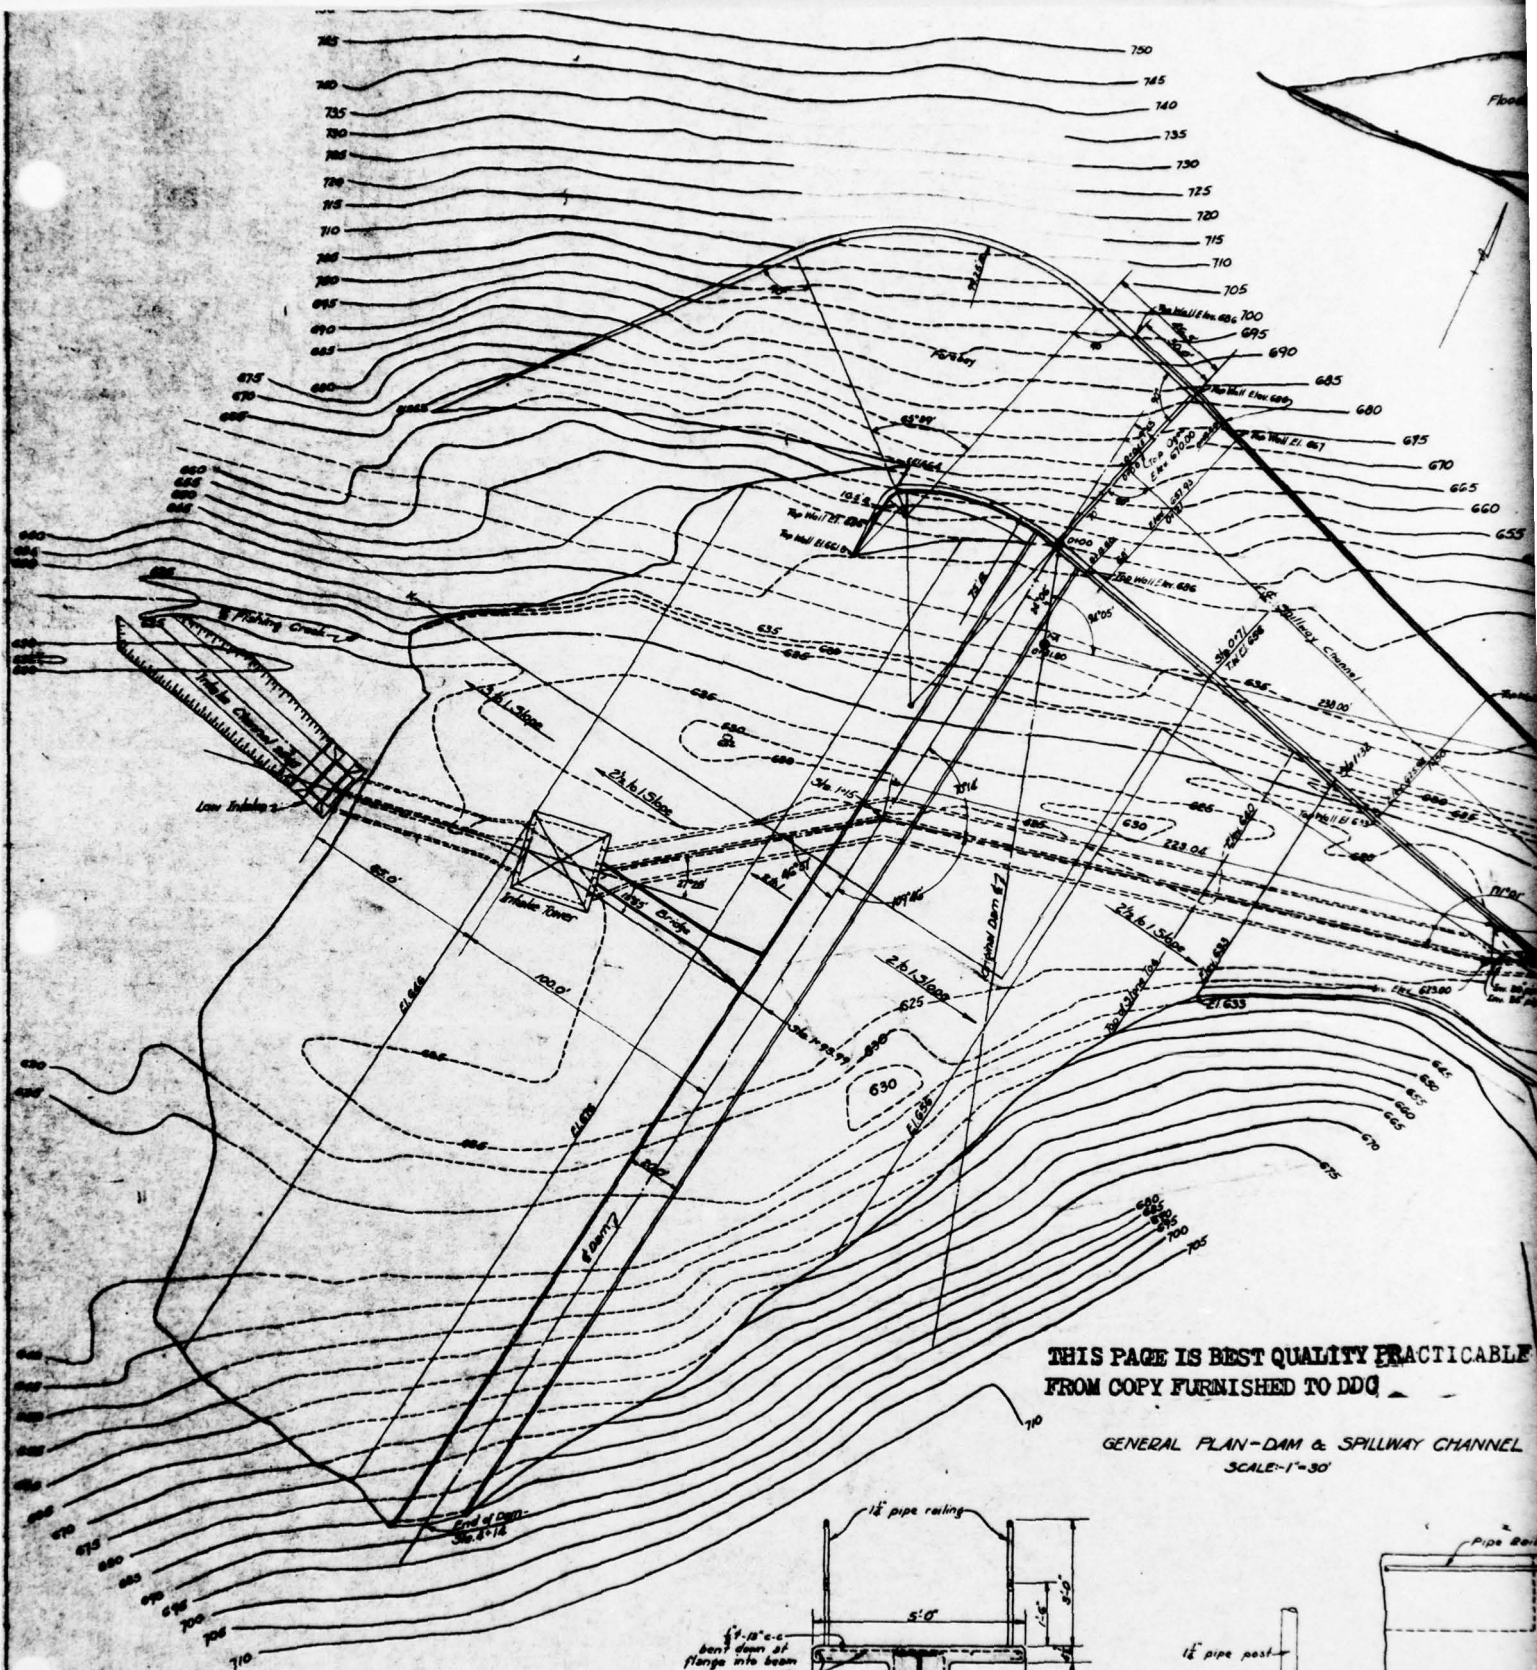
GENERAL PLAN-DAM & SPILLWAY CHANNEL
SCALE-1"=30'

During the construction period modifications to the location of the dam axis were made as a result of unstable foundations at the initial right abutment location (Appendix D, Plate VII). An additional construction change involved the foundation for the inlet control tower and the outlet pipe support foundations. Depth to the designed rock foundation level was considered excessive and the foundations were modified to rest on the overburden soils. Other design features were constructed according to the plans. The project was completed on September 15, 1948.

There are a number of periodic inspection reports by PennDER personnel during the initial construction of the dam. The major change in the design was the realignment of the dam axis as a result of the discovery of unsuitable embankment foundations. Refer to Appendix D, Plate VII for plan view showing original axis and changed axis.
